Anchor Shoring Celebrates 40 Years of Growth and Innovation

by Sasha Gollish, B.A, B.E.Sc and Dawn Tattle, P. Eng

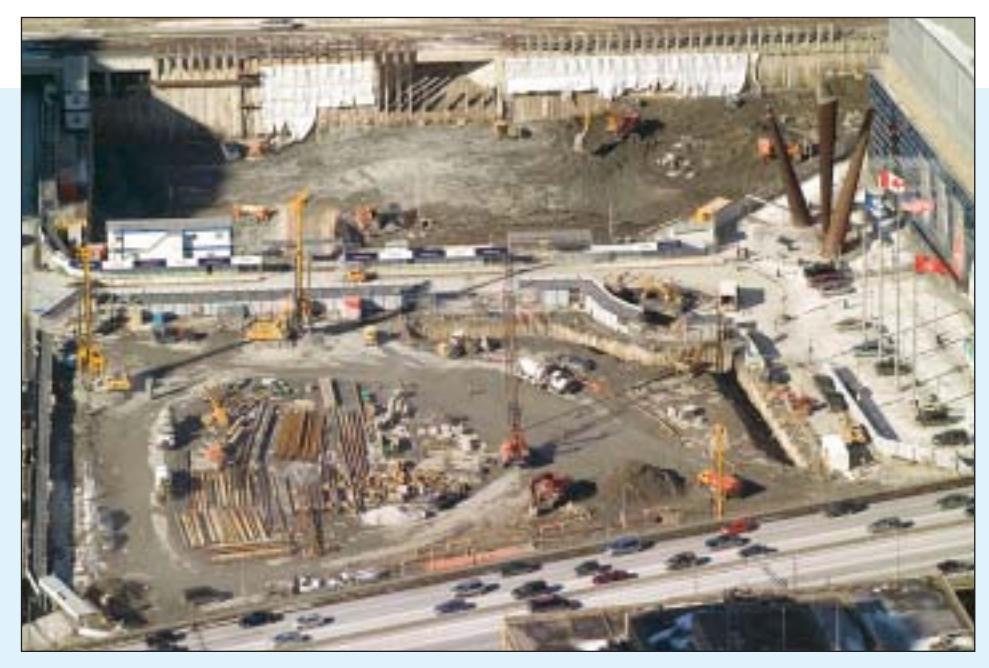
Overview of Maple Leaf Square site (bottom) and TELUS site (top), Air Canada Centre (right). Anchor Shoring was the contractor on all three projects.

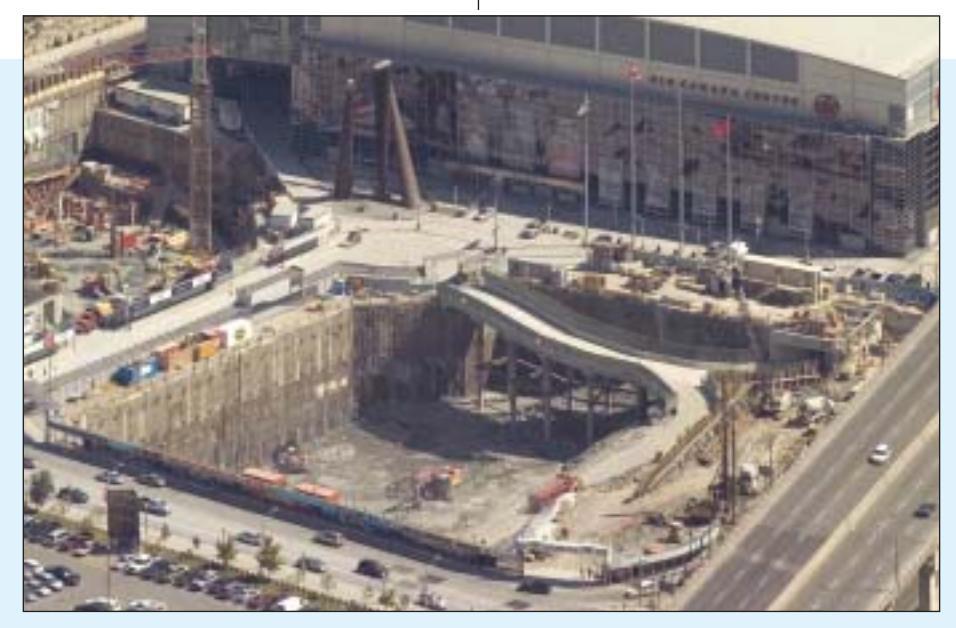
Aerial view of completed caisson walls, rock protection, temporary ramp, sheet piling and drilling of south caisson wall at the Maple Leaf Square Project.

Situated near Lake Ontario, on reclaimed land, the Maple Leaf Square Project required a continuous caisson wall system to act as a water cut-off wall above the shale surface around the perimeter of the site. With an excavation depth of approximately 65ft, the building is founded 43ft below the surface of the shale bedrock.

A caisson wall is composed of a series of interlocking drilled holes which are backfilled with a weak concrete mix with strength of about 4MPa. Steel soldier piles are placed at specified intervals in the wall to provide lateral and vertical support. The caisson wall at Maple Leaf Square required

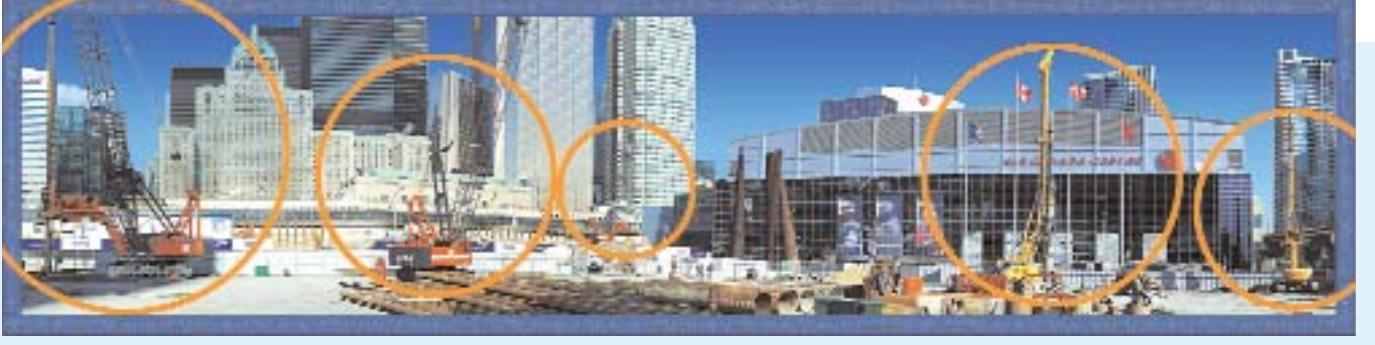
Drilling caisson walls and structural caissons with crane mounted and track mounted drilling equipment at the Maple Leaf Square and TELUS sites.

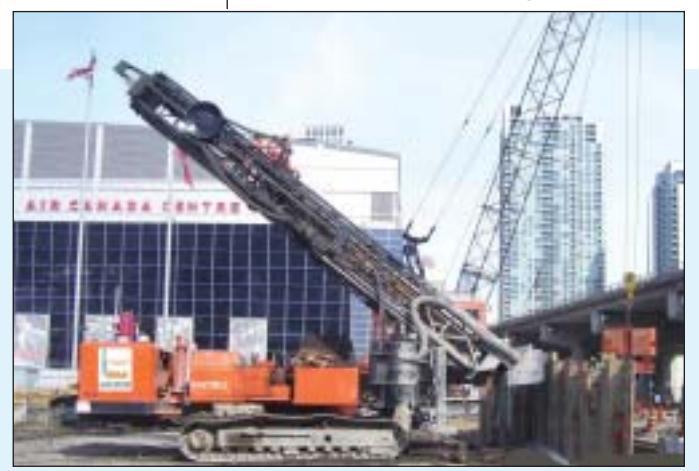
Installation of rock anchors by Crown Drilling to brace the south sheet pile wall at Maple Leaf Square.

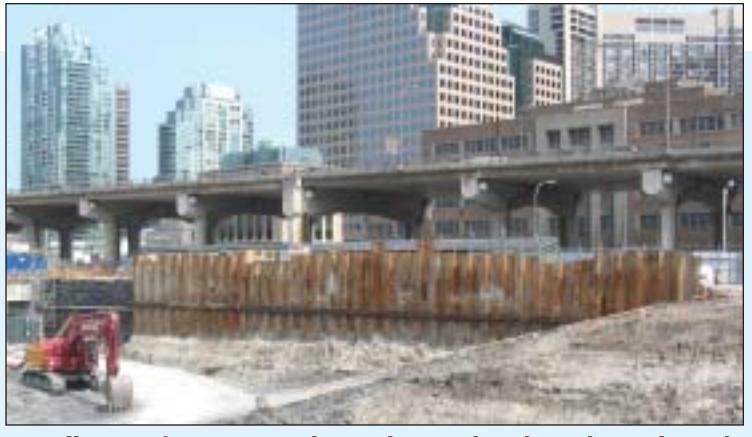
Installation of temporary sheet piling and rock anchors along the south wall is complete. Excavation is continuing.

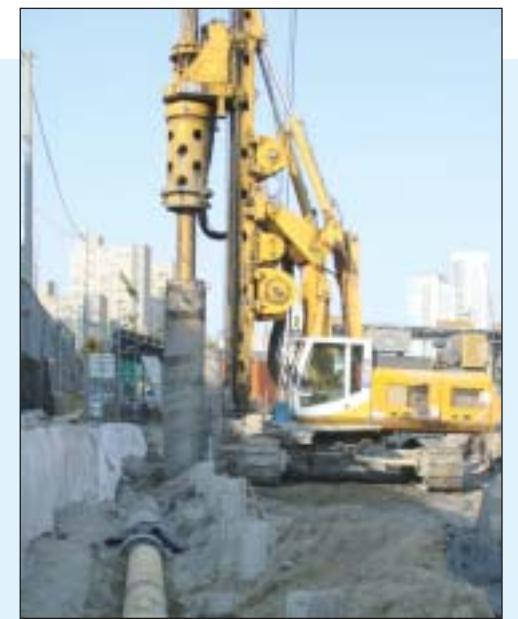
Anchor drilling adjacent to live gas main with a BG24H for the south caisson wall.

This south caisson wall was the most difficult and complicated of the job due to the close proximity of a live 16in diameter gas main and the presence of existing shoring from construction of the Air Canada Centre which would interfere with drilling for the new caisson wall. The gas main was located only four inches from the edge of the proposed caisson wall drill holes. Prior to final design of the shoring in this area, the gas main was exposed to determine its exact location. To protect it during drilling, several sections of 24in diameter steel liner were cut in half and compressible material was fastened to the inside of the liners. This was placed on top of the gas main to completely cover it during drilling operations. A Bauer BG24H was used for drilling the caisson wall in this area as its sectional casing and auger system minimizes potential disturbance and vibration, which was required in this extremely sensitive area.

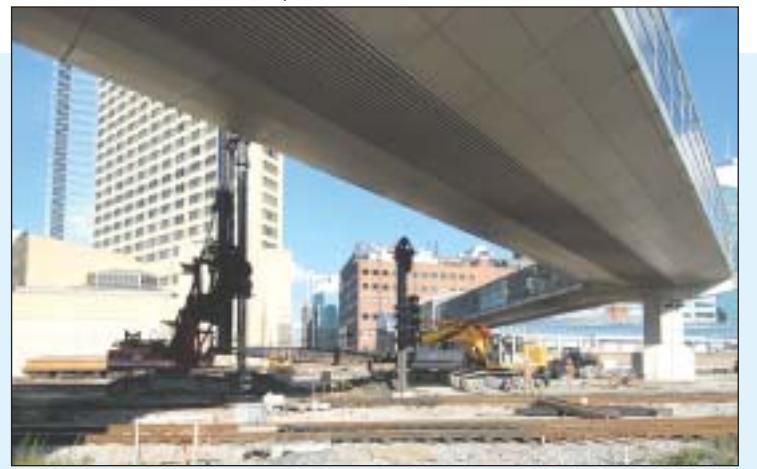
Drilling soldier pile holes at track level for the Simcoe Extension project. A LoDril is working below skywalk. An IMT is drilling for piles in areas with unrestricted headroom.

The Skywalk, an elevated sidewalk connecting the Roger's Centre to Union Station borders the east edge of the project. The Skywalk crosses over the CN rail yard and above the new tunnel structure. This height restriction complicated the installation of the 22 piles below the Skywalk by reducing the available headroom to less than 23ft in this

area. The soldier piles were required to support vertical loads from the temporary train trestles and permanent loads from the structure. It was specified that they be socketted ten feet into shale. To accomplish this drilling under work these challenging conditions Anchor Shoring

purchased a LoDril DH60-60* mounted on a Liebherr 944* excavator. Due to the extremely poor ground conditions and low headroom available, double and triple lining of the drill holes was required to ensure that loss of ground did not occur. To further

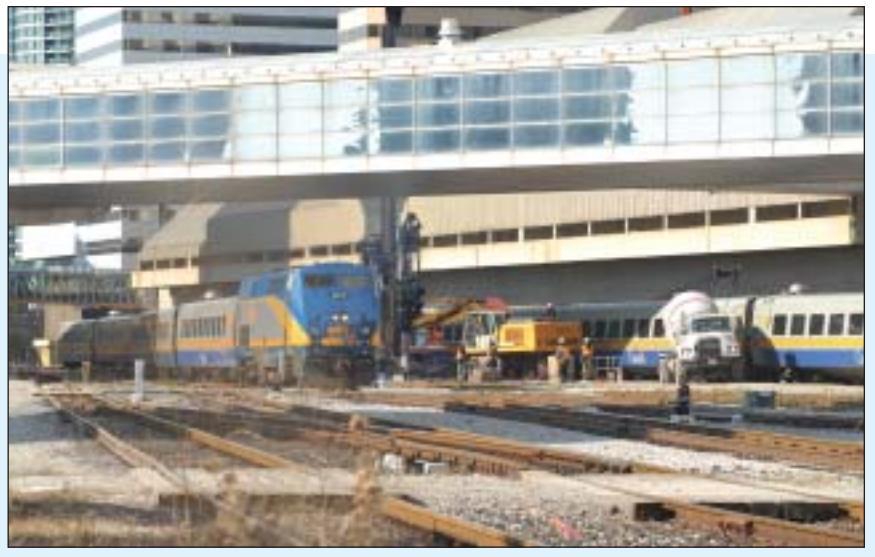
LoDril and IMT drilling at the Simcoe Extension project. Note restricted working area between trains for drilling and placing concrete.

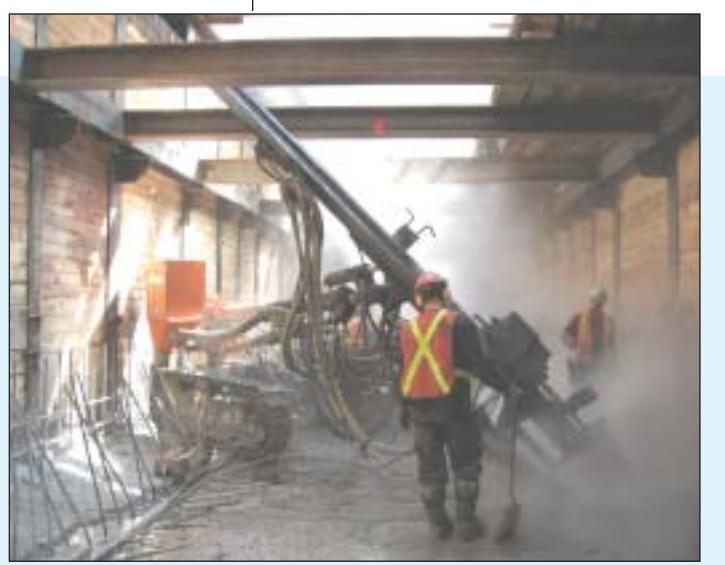
Drilling DCP rock anchors from tunnel base slab.

(DCP) rock anchors. These rock anchors were drilled along the outer east and west walls of the tunnel and were required to prevent overturning. The bedrock here was highly fractured and required that many of the rock anchors to be grouted, left over night, and re-drilled the following day. This ensured that fractures were sealed and that the necessary capacity could be reached. The two working tunnels were quite narrow, one was 25ft and the other only 22ft, and headroom was limited by the struts. Conventional rock anchor equipment could not be used. Anchor elected to use a modified Airtrack drill rig for this work. It was necessary to install the Dywidag* DCP tieback bars in two pieces and con-

nect them in place with a coupler as the anchors were 40ft long and the tunnel width was a maximum width of only 25ft.

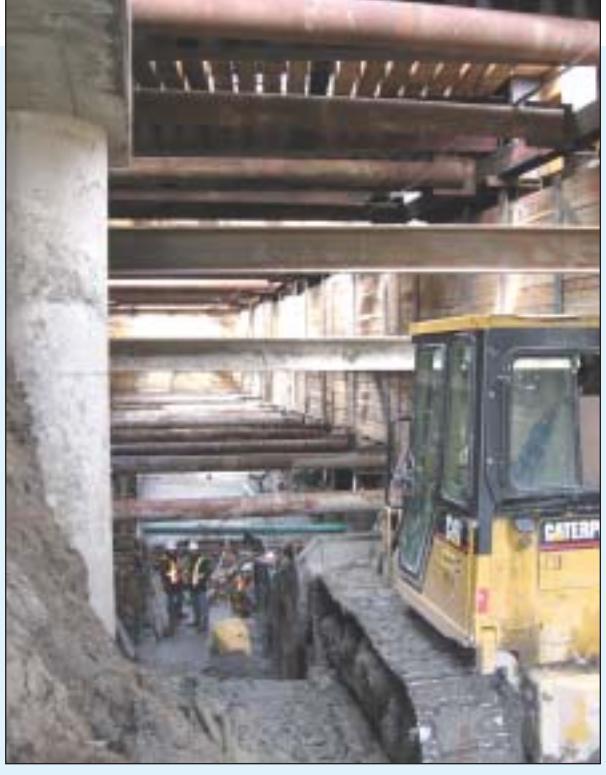
Three rows of struts have been installed to brace the shoring walls. Excavation continuing to top of shale bedrock.

There were a total of three bracing levels required to provide lateral support to the shoring system. Continuous walers were installed at each of the three levels and struts were installed between the opposing shoring walls. Accurate placement of piles in a straight line and to the proper elevations was essential due to the complicated

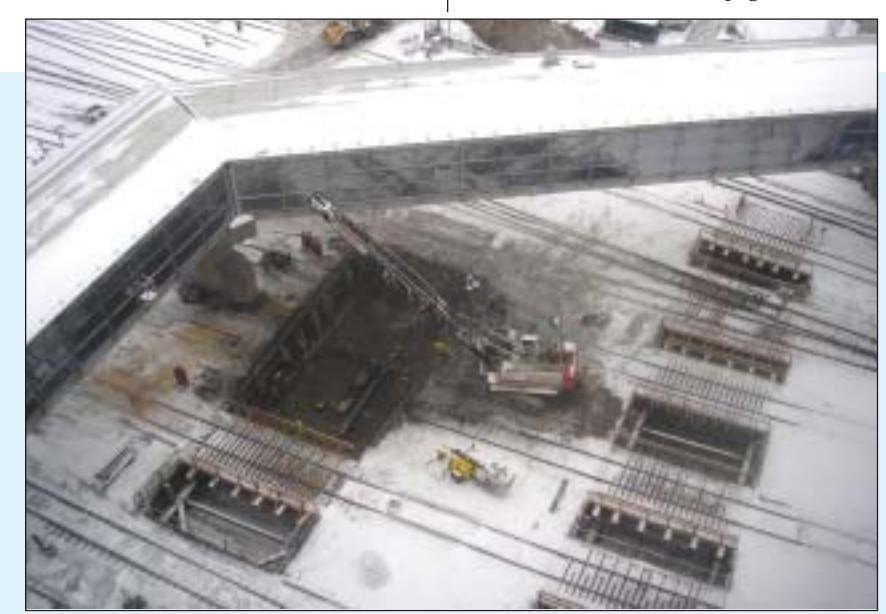
Aerial view of track level at the Simcoe Street Extension. Trestle installation work underway. Five trestle bridges are complete.

Further complication of the project was the condition that each of the two open cut trenches intersected 13 live train tracks. It was necessary to install temporary steel trestle bridges to support the trains above the open cut during excavation and construction. The vertical load from the trains was supported on W24x162 piles, which were socketed into the shale bedrock. These

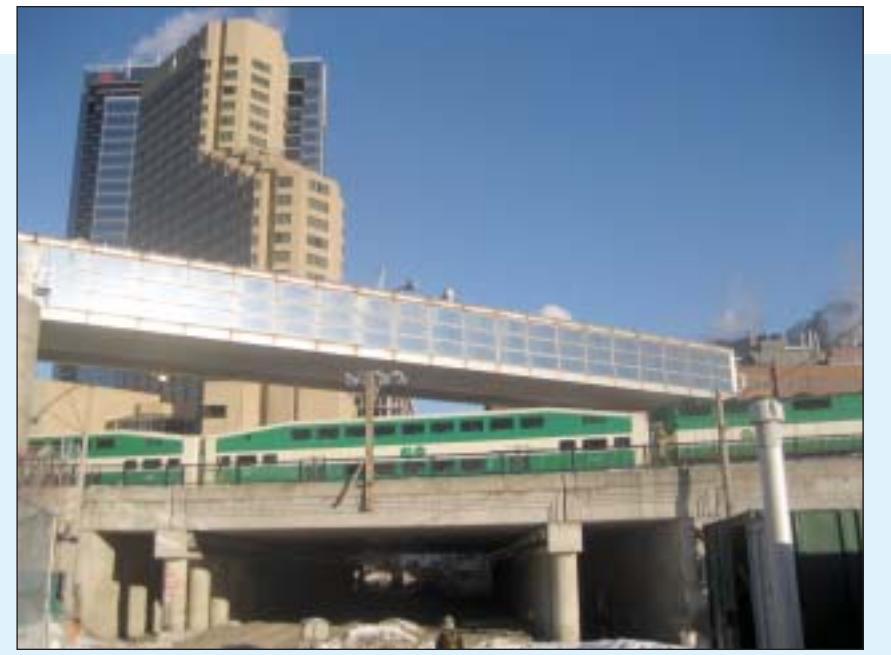
Completed Simcoe Tunnel structure.

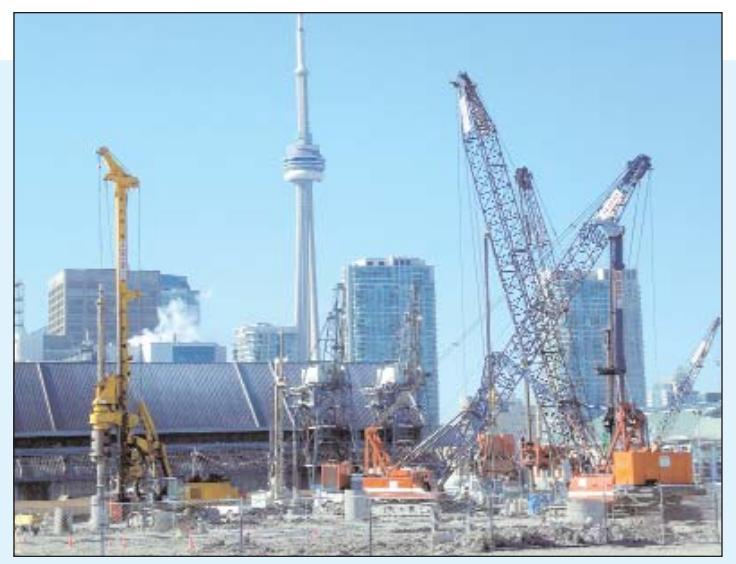
Installing caissons at the Corus Entertainment Headquarters with a Bauer BG28H, a Hain drill mounted on an LS208 crane, an IMT AF180 drill rig and associated support equipmen

To minimize vibrations in this sensitive area a Bauer BG28H was selected. The Bauer machines use an integrated auger and liner system to install sectional casing without the need of a vibratory hammer. The casing is advanced prior to drilling to ensure that ground loss does not occur. Open-hole drilling was not an option here as the soil strata ranged from wet sand and
